BOARD OF SELECTMEN AGENDA July 9, 2015 – 7:00 P.M. Sandwich Town Hall – 130 Main Street

Assessment Report

Re: Clark-Haddad Memorial Building
Structural Condition Assessment

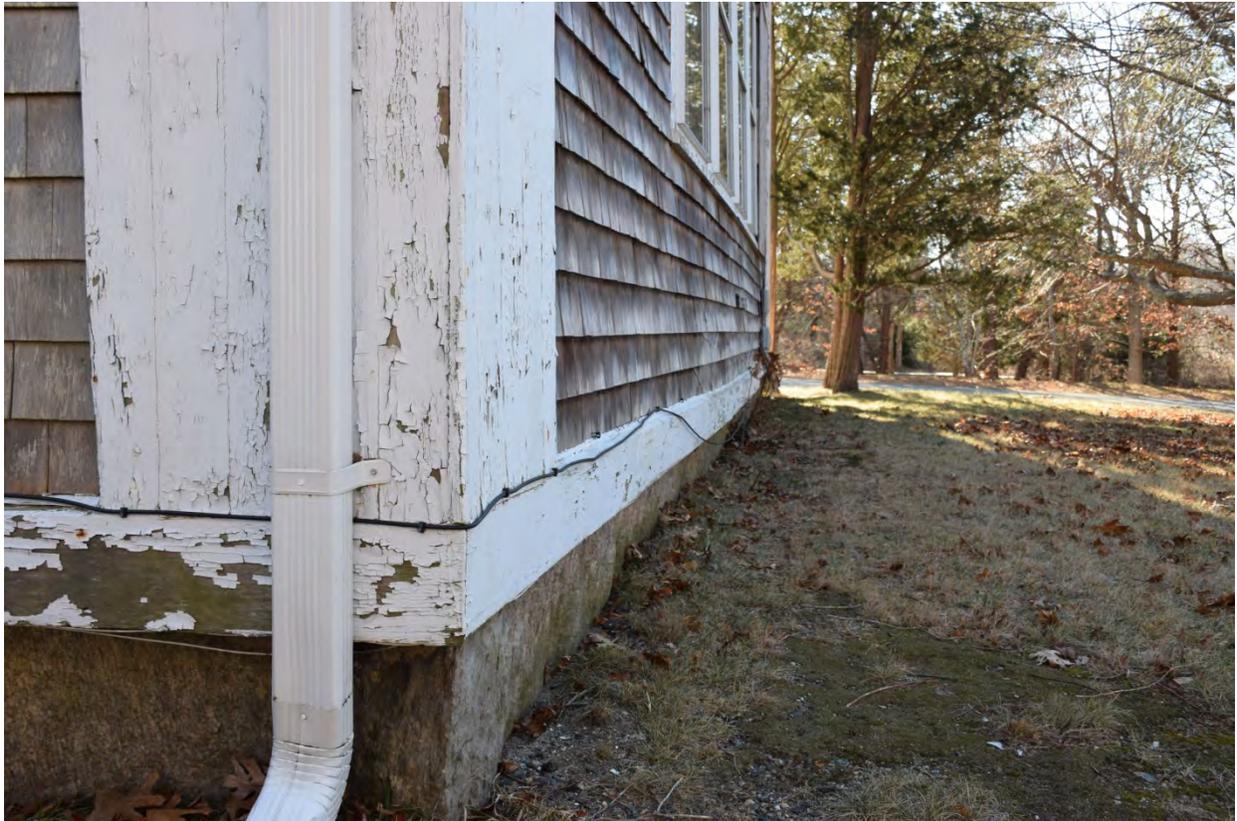
The building still has the wide built-up corner boards, and the wide frieze board, and water table board that are evident in the historic photograph. With the exception of some repairs, these trim boards are most likely original to the building. At the west elevation one can observe a slight bow in the water table trim, indicative of the possible sill deterioration that is discussed in more detail in the attached structural assessment (see photo 5).

Photo 5: Detail photo shows typical aluminum downspout and bow at watertable, West Elevation

The bow in the west wall at the sill suggests the sill is pulling away from the supported floor joists. There is no thrust associated with the geometry of the vertical wall and horizontal floor to cause this. Again, I would attribute this to decay in the wood sill.

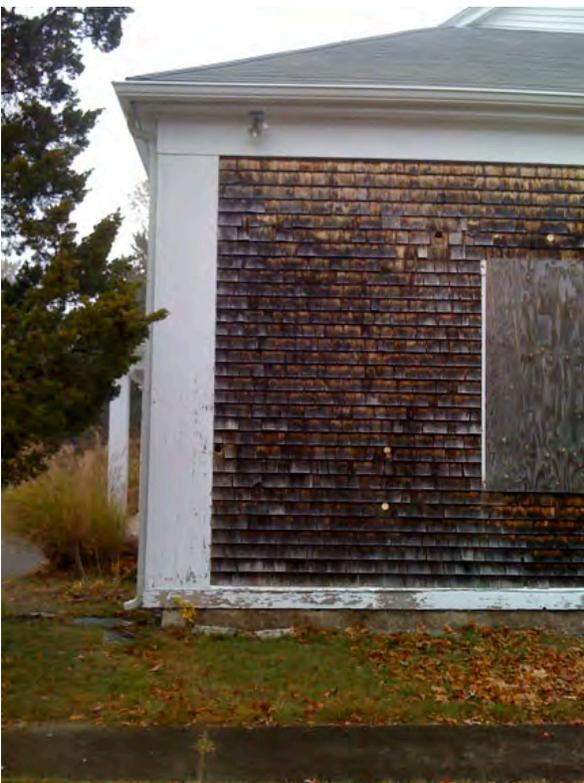
Photo 6: Detail showing poor shingle condition at the East Elevation

Deteriorated clapboards, shingles, and selective areas of trim should be replaced in a restoration of the building. The decision as to whether to return to all clapboards, and whether to

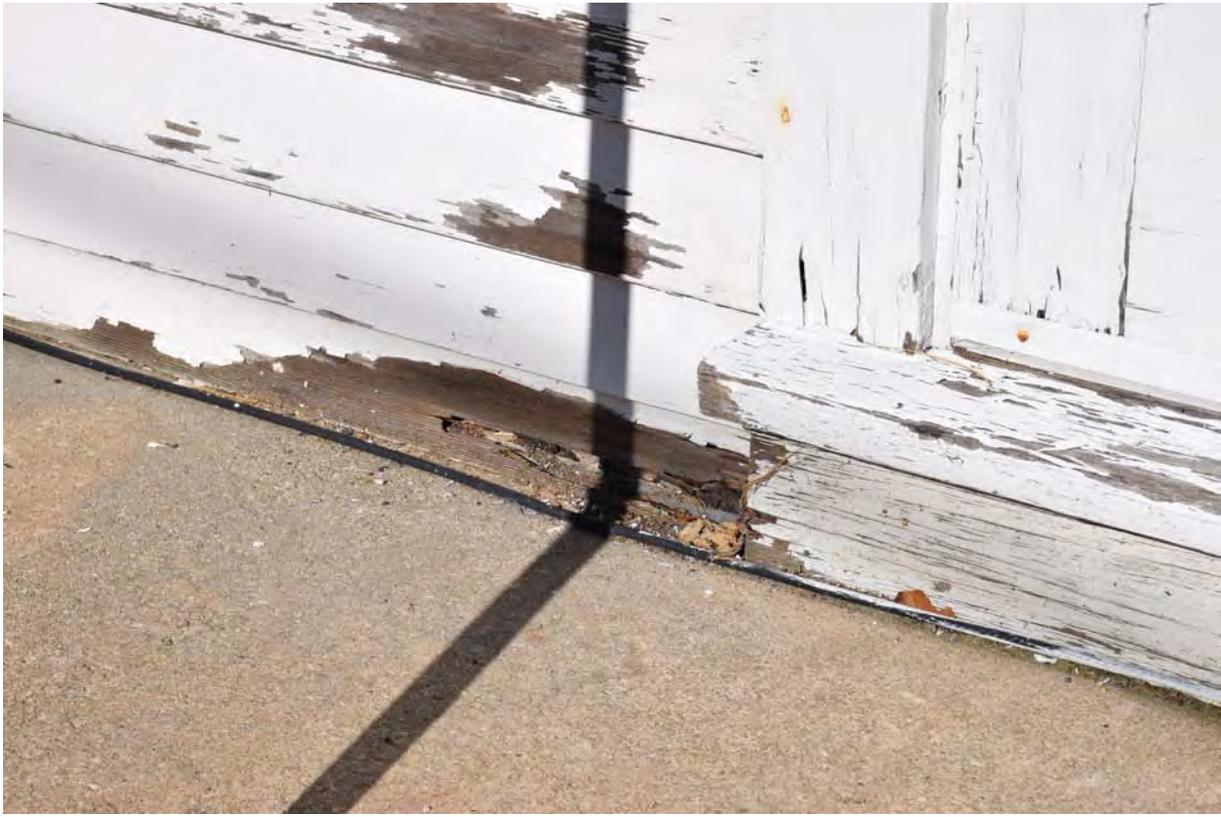
Again, looking at the historic photo, the building was originally clad with clapboard siding on all elevations. Currently the building features clapboard siding on the front (south) elevation, with cedar shingles used as cladding on the remaining elevations. The shingle condition varies greatly, with those of the east elevation showing the most deterioration (see photo 6) and there is evidence of newer replacements in areas of the north elevation. At the east elevation, one can see where shingles were removed to provide port holes for the installation of foam insulation at the exterior walls. In some locations these port holes have now become nesting spots for birds. There is some localized deterioration of the clapboards on the south elevation (see photos 7 and 8) The current paint is peeling and a restoration should include repainting.

Photo 7: Clapboard and trim deterioration at the South Elevation

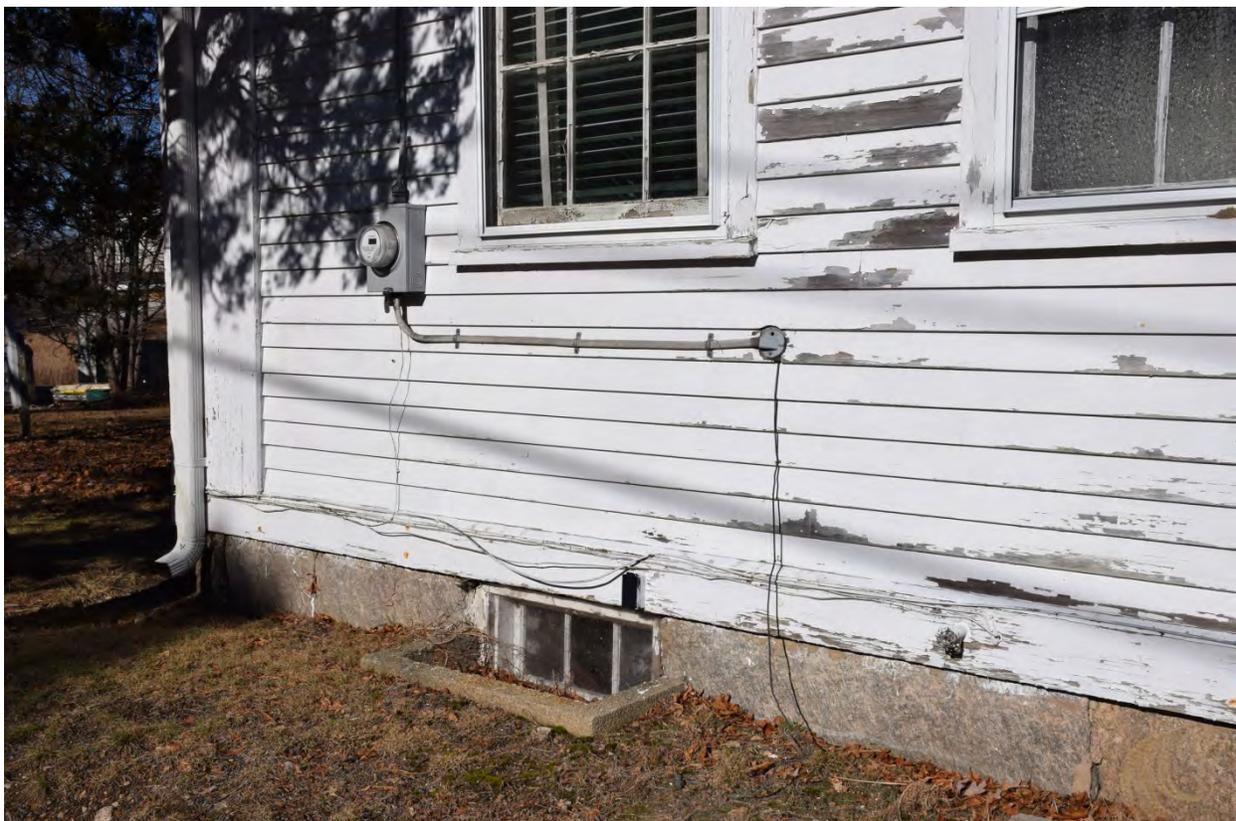
Photo 8: Detail of clapboard and trim condition at South Elevation

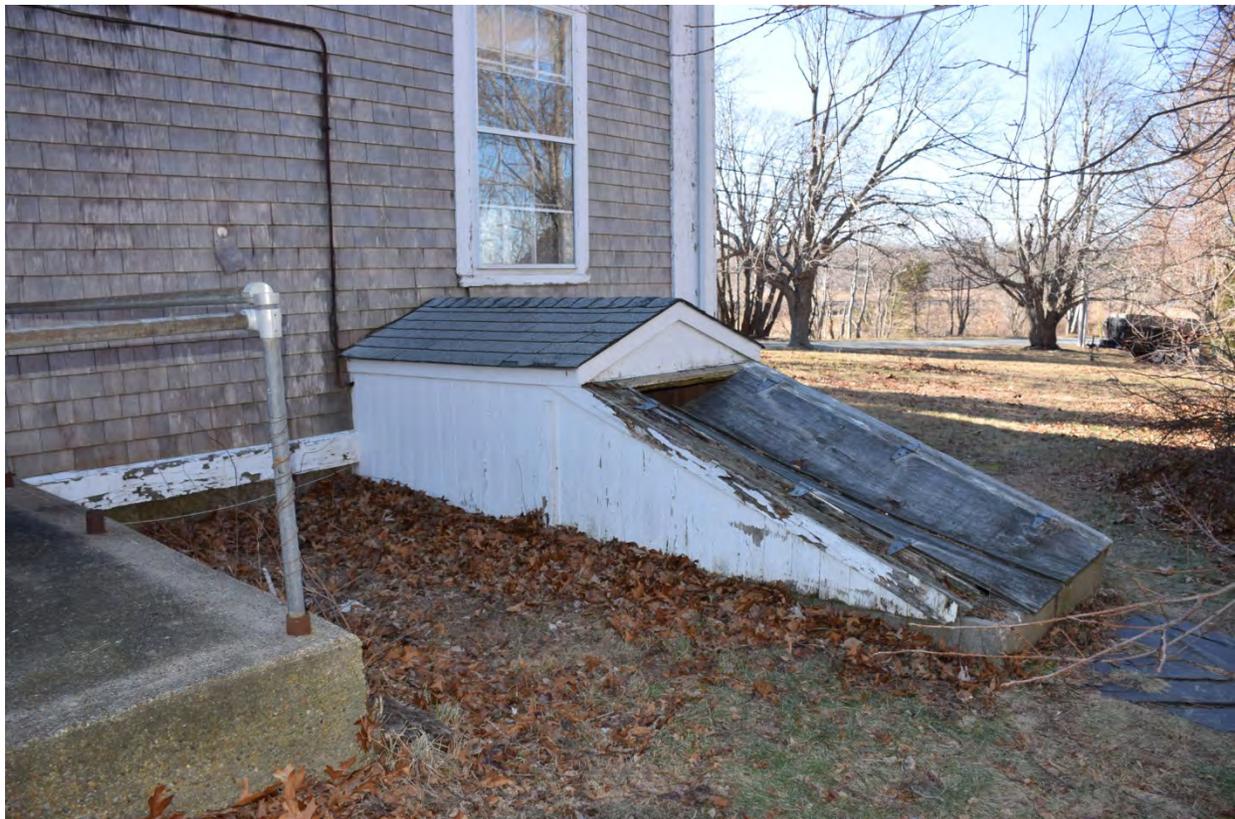
The bulkhead structure on the north elevation is very badly deteriorated and if it is decided to keep this exterior access to the basement, then it should be completely rebuilt. (see photo 12). The existing first floor exit door adjacent to the bulkhead is a metal door that is extremely rusted (see photo 13)

Photo 12: Detail of deteriorated bulkhead access to basement

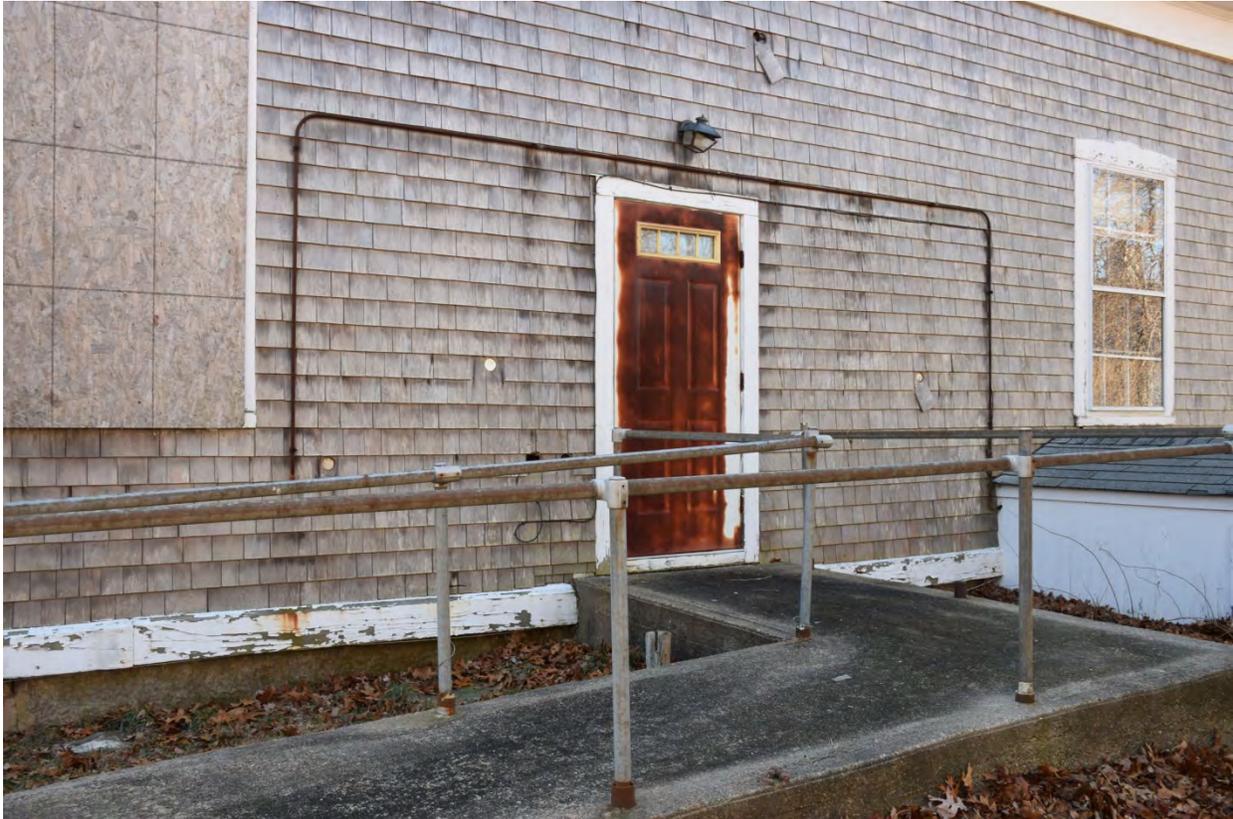
Photo 13: Detail at rear ramp and exit door

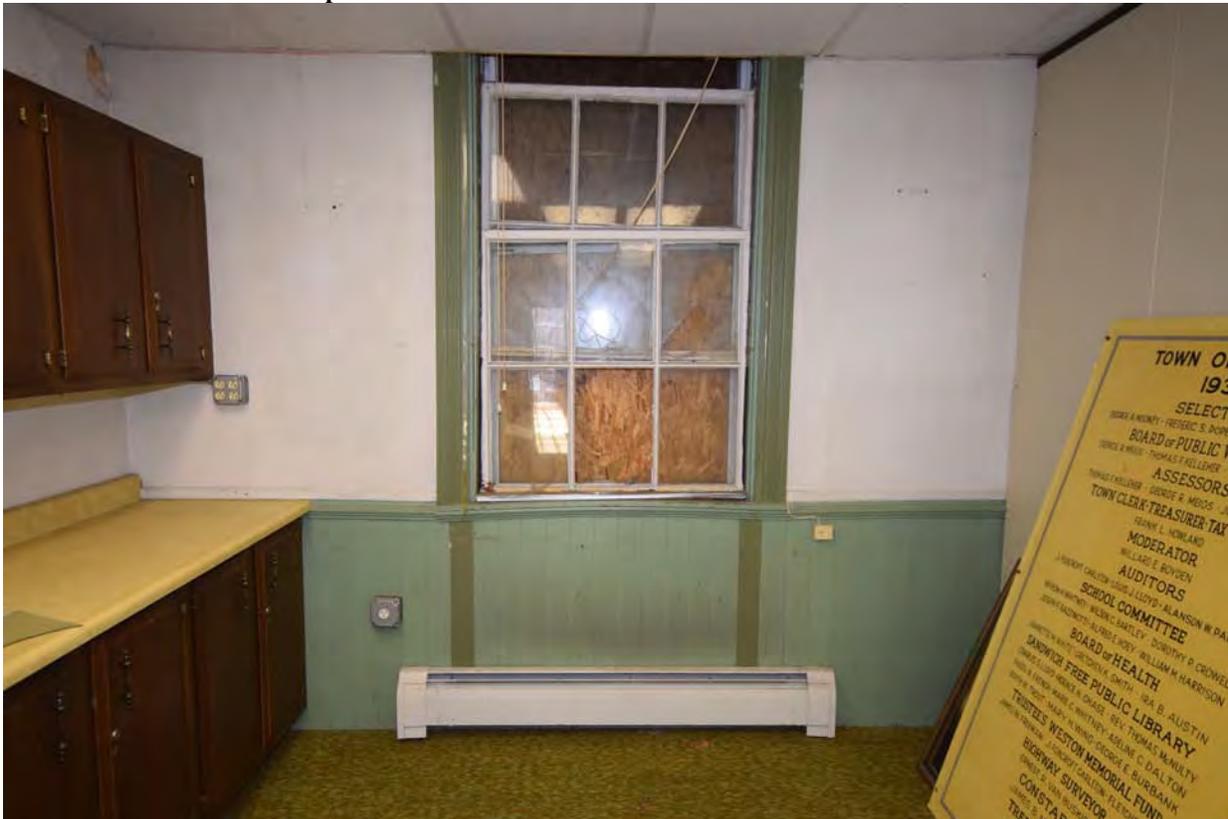
As noted above, the windows have changed in size, location, and number since the building was originally constructed. The windows that exist today appear to be from the 1935 era WPA renovations. Today the windows are in poor condition, and would be much worse if the existing aluminum storm windows had not been added to protect them. The windows have broken glass, missing and deteriorated glazing putty, and have a bowed sill condition that is discussed in more detail in the attached structural assessment (see also photo 14) A wide number of options exist for windows as restoration/repair strategies for the building. The window sash can be restored and improved with new hardware and weatherstripping, window sash only could be replaced, or the entire window could be replaced. Replacements will offer further options to choose from, including material, glazing type, and muntin type and layout. All of this depends on budget and the overall preservation strategy. It should be noted that hazardous materials testing in 2012 identified that the glazing putty contained asbestos, so abatement and legal disposal must be done with whatever treatment option is selected.

Photo 14: Detail of window on the north wall shows the typical condition of windows (this one has exterior protective boarding) Note deformed window sill indicating possible rot at the wall sill

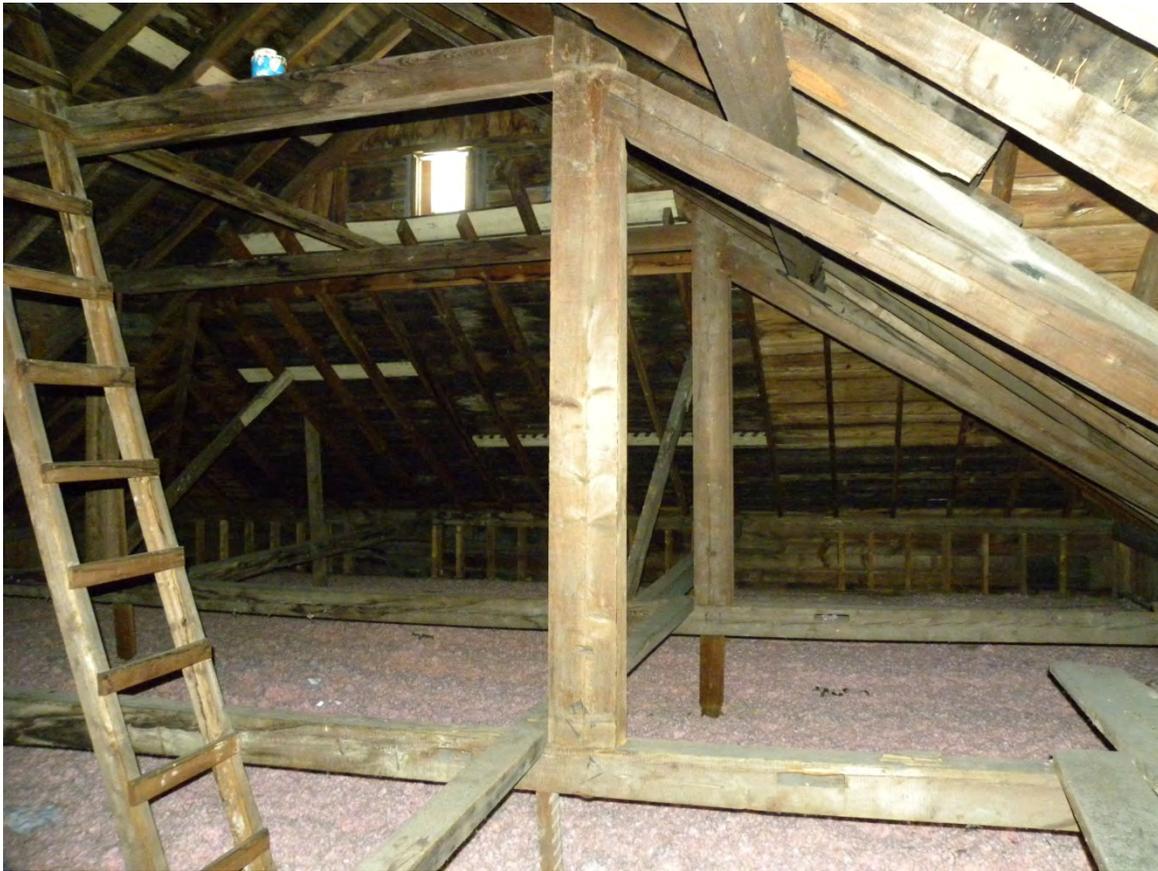
The building's attic is unfinished, though its floor is sheathed with board flooring, but not completely (see photo 24). Currently about 8" of chopped cellulose insulation has been loosely blown over the floor boards. The timbers that comprise the roof trusses were used in another structure prior to construction of the school. They exhibit mortise and pin holes that are

Photo 24: Overall view of attic

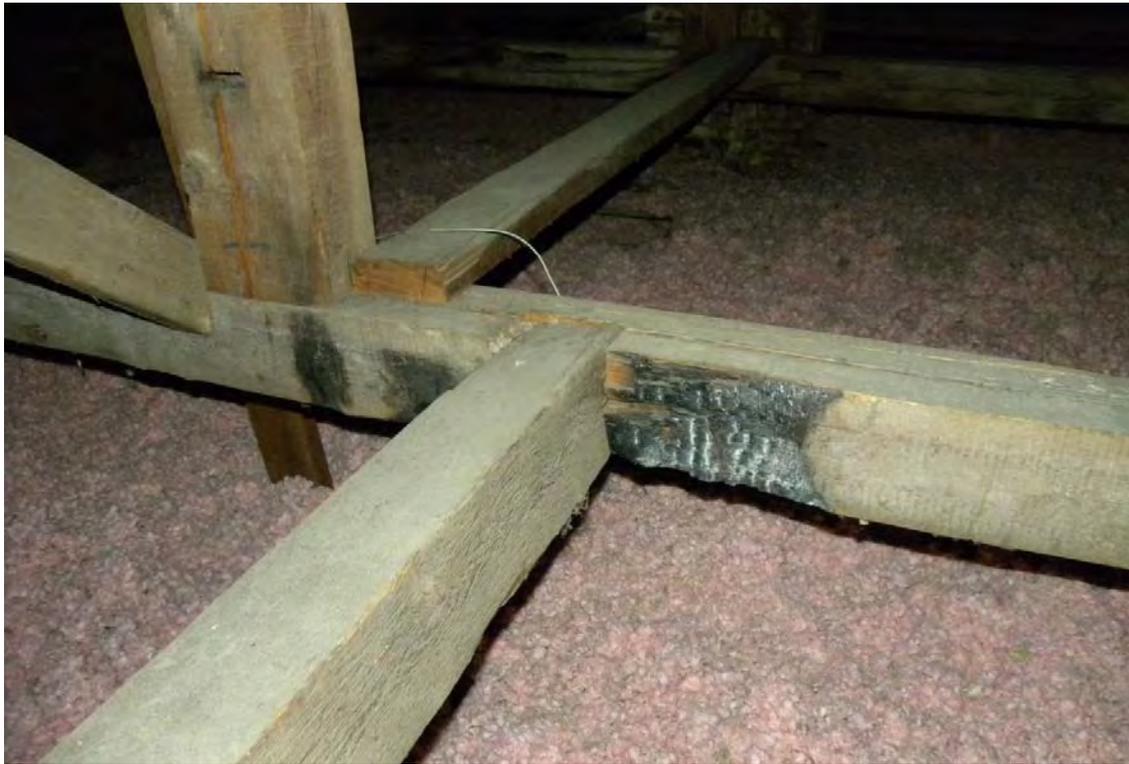
irrelevant to the current structure, and there was charring present in one location (see photo 26). A reasonable theory is that some of these timbers may have been used in the previous school building. The attached structural assessment further addresses condition and recommendations regarding attic framing.

Photo 26: Detail view of truss members. Note char on horizontal member.

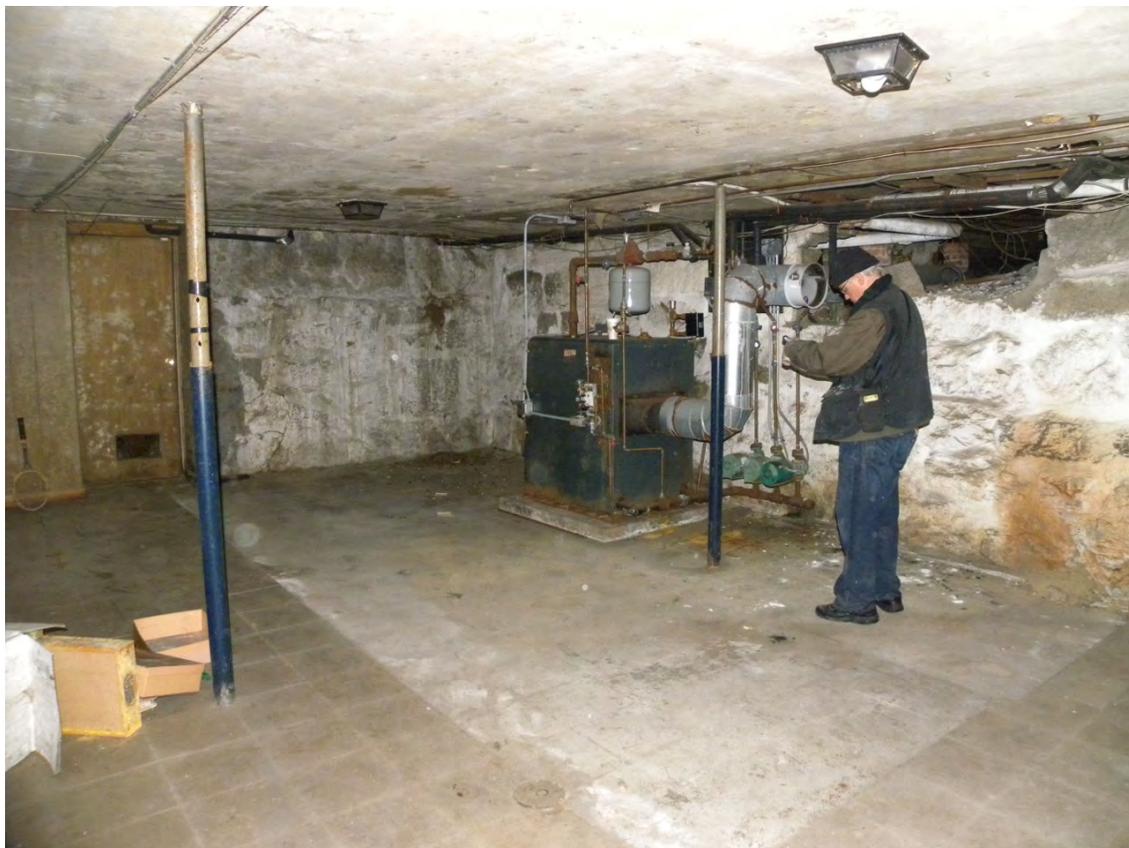
There is a full basement under the west half of the building, while the east half features a partially excavated crawl space (see photo 27). The basement is accessed by an interior stair in the southwest corner of the building, and by a bulkhead stair to the exterior on the north side of the building. The basement was used as an activity room during the American Legion's use of the building. Presently the boiler is located in the basement (see photo 28), and a separate small room houses the alarm and telephone/data panels and the fuel oil tank (see photo 29). The basement ceiling is finished with wall board with plaster. There are vinyl tiles on the floor, that were identified as asbestos-containing in the 2012 report. The pipe insulation that runs in the crawl space was also identified as asbestos containing. These materials will have to be abated as part of any construction project that takes place in the building.

Photo 27: Basement. Note asbestos-containing floor tiles and pipe wrap

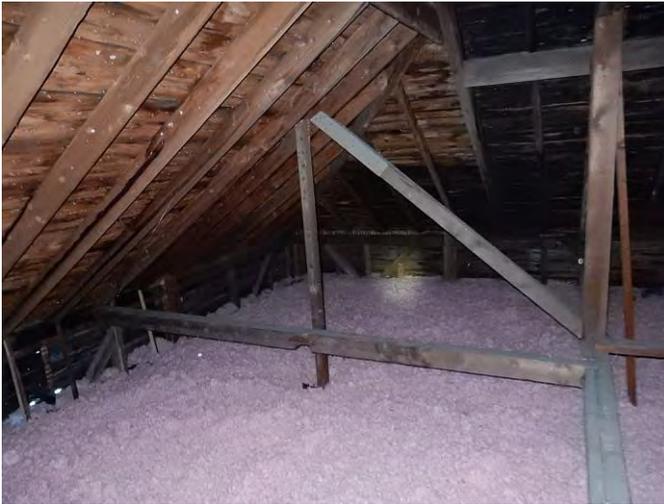
Attic floor framing. The attic joists are likely covered with board sheathing. Some areas of flooring have been removed most likely by trades accessing electrical wiring. The insulation covering the floor makes walking on it a hazard. The 3 by 10 joists have a live load capacity approaching 300 psf. The beams have a capacity to carry a live load of 38 psf. Again, the disparity is striking. The hangers supporting the ceiling beams are grossly undersized and provide little opportunity to develop adequate connection support. The support of these hangers on single rafters is also dangerously undersized.

1. Roof framing under west end of building. Note two 2x wood hangers, one hanging from the truss and one hanging from a rafter, support beams beneath the insulation which support ceiling joists. The insulation covers board flooring and conceals random openings in the flooring.

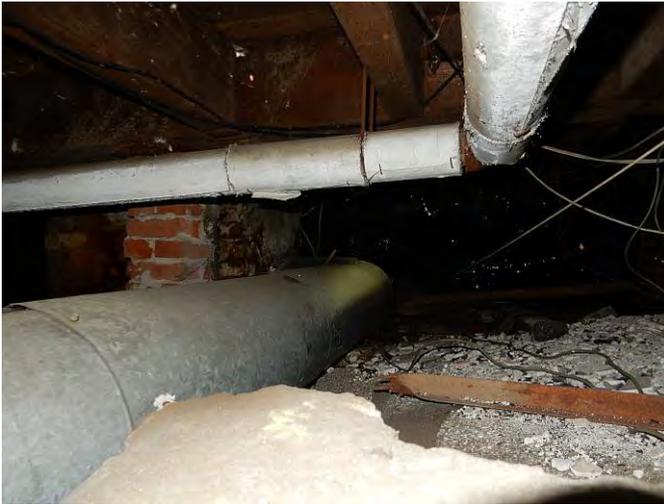
Crawlspace. Crawlspaces can be hostile to wood framed floors as they can hold moisture favorable to many organisms that consume wood. The Code standard is to keep joists at least 18 inches above earth. Here most of the space is about 20 inches clear. The Code calls for natural ventilation on at least three sides with openings preferably near corners to ensure adequate air flow. At present, the natural ventilation conditions are not met.

7. Crawlspace under the middle and east side of the building. Generally, the odor is free of any scent of decay. The space does not have adequate cross ventilation.

Crawlspace. Provide openings in the exterior walls or install mechanical ventilation to move air sufficiently to keep the space dry. The need for ventilation is to reduce moisture during warm seasons when decay causing organisms are active. A mechanical system could dry and recycle the same air to minimize temperature change effects of fresh air.

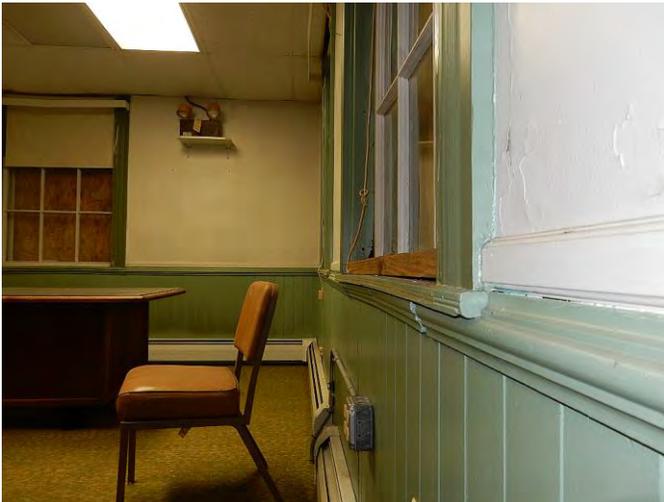
The crown in the window stools indicates framing next to windows is sinking into the wood sills. This is happening on all sides of the building. The scale of the building is not so great that the bearing weight is crushing the wood from overstress. It is more likely the sills have some degree of decay that has reduced its cross grain bearing stress.

8. Window stools are crowned because of framing around them settling suggesting the wall studs are sinking into the foundation sills.

First floor framing. The decay in the foundation sill needs to be abated to prevent further spread into the floor framing and provide adequate support for the walls. This will require carefully lifting (for reuse) skirts on the exterior walls to access compromised wood. The percent of affected framing is unknown as it is concealed. After removing the skirts and sheathing, survey the sills and replace rotted portions. Following replacement of sills, apply Bora-Care wood preservative to all exposed wood before closing up with finishes.

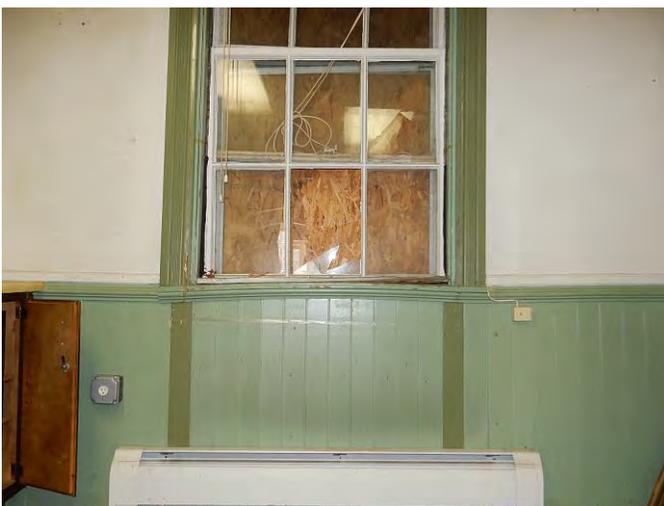
9. Another view of a window with a crown in the window stool.
