BOARD OF SELECTMEN AGENDA July 9, 2015 – 7:00 P.M. Sandwich Town Hall – 130 Main Street

Assessment Report

Re: Clark-Haddad Memorial Building
Structural Condition Assessment

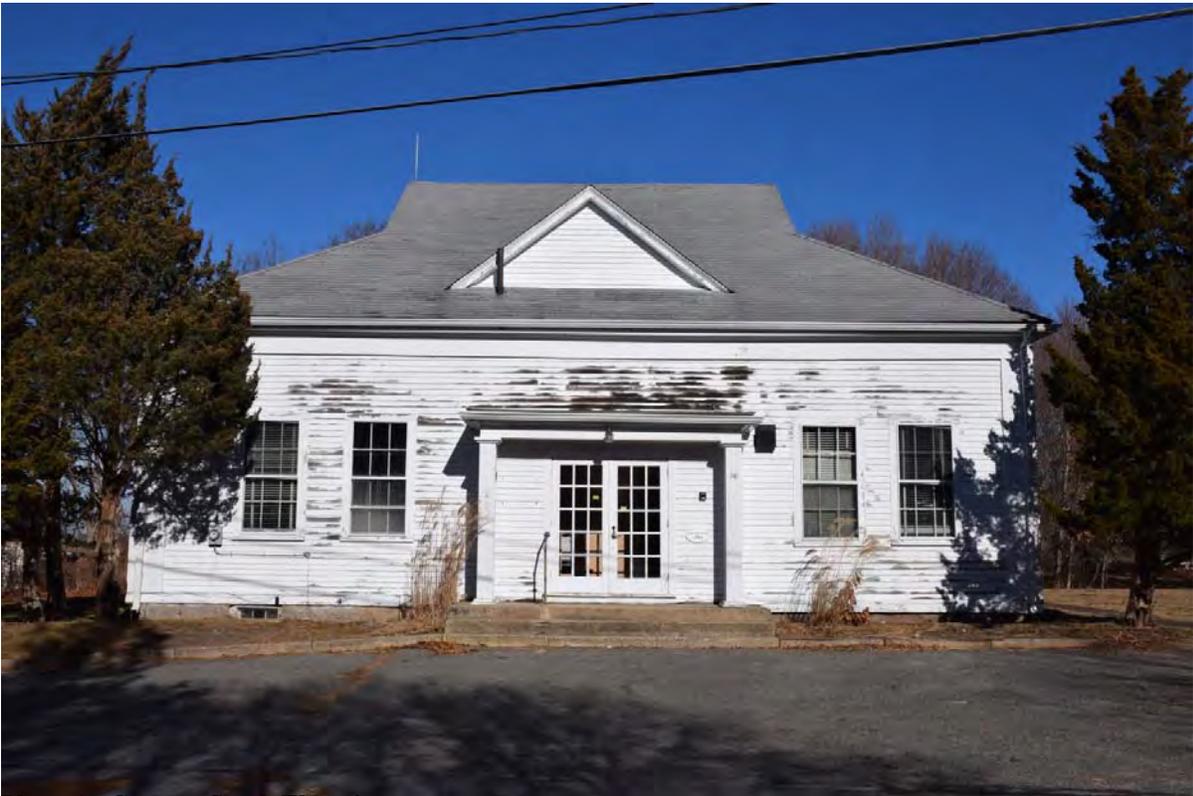
Photo 1: Current South Elevation

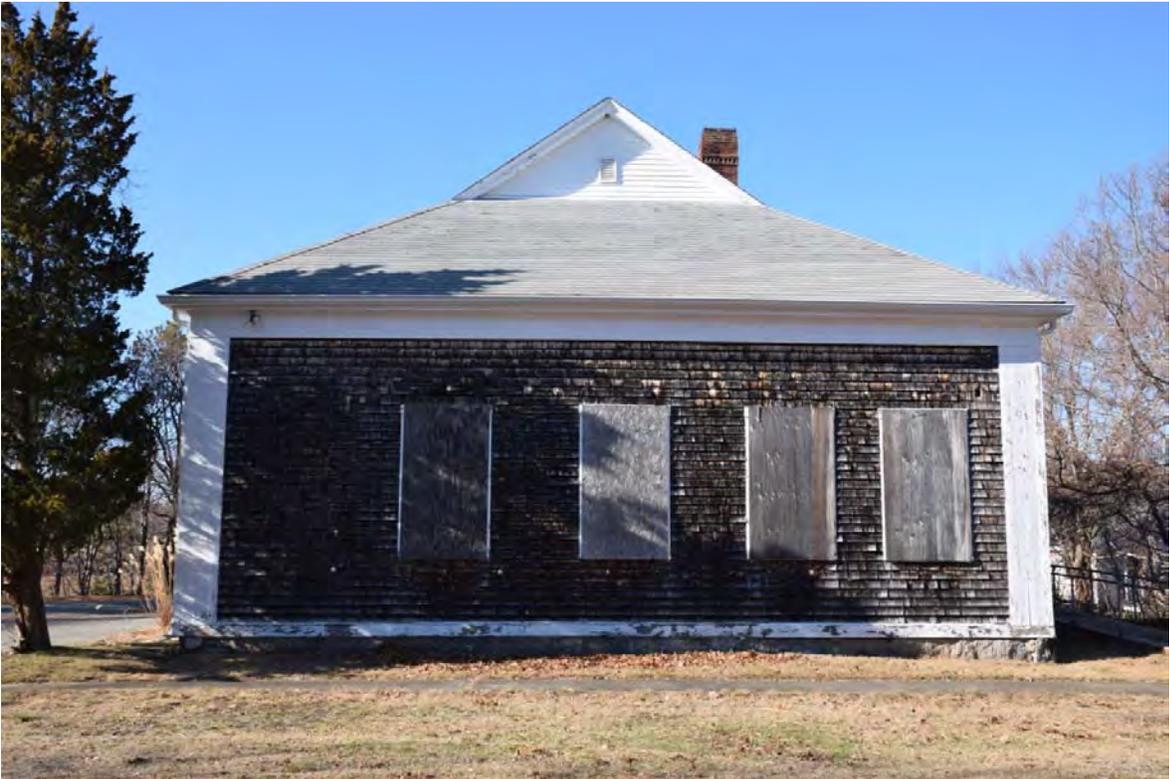
Photo 2: Current East Elevation

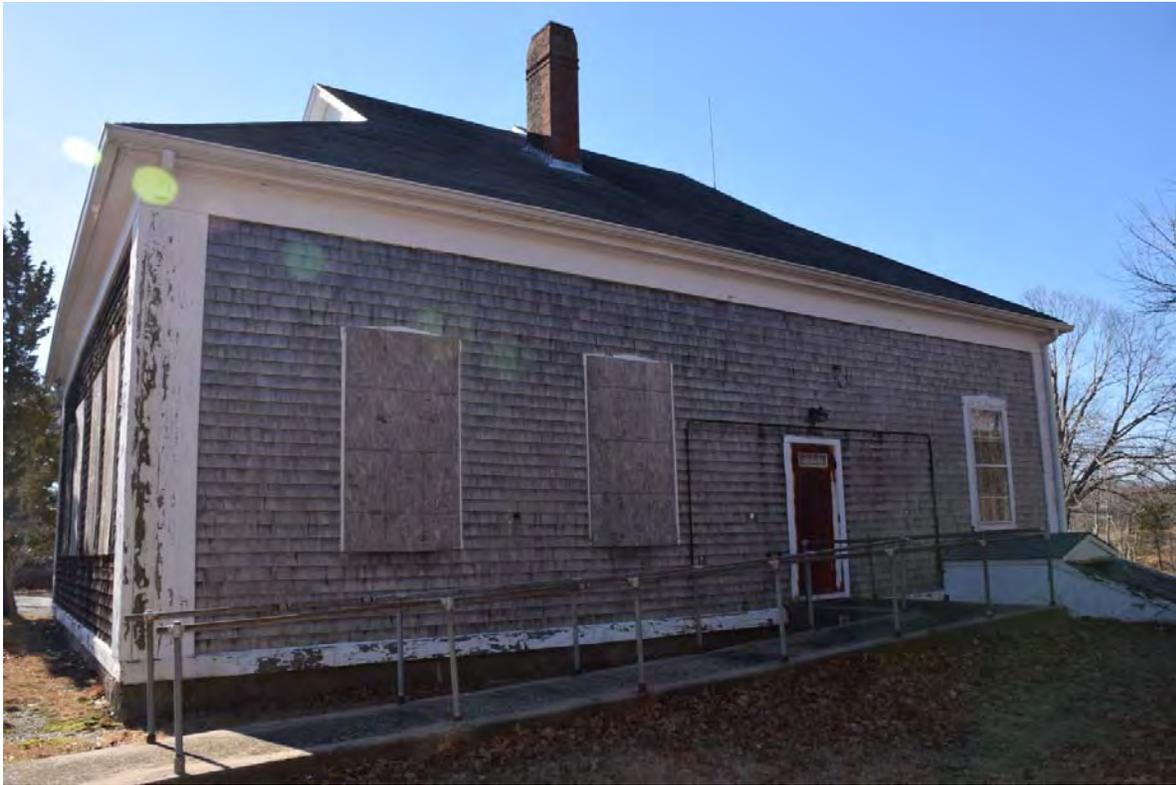
Photo 3: North Elevation

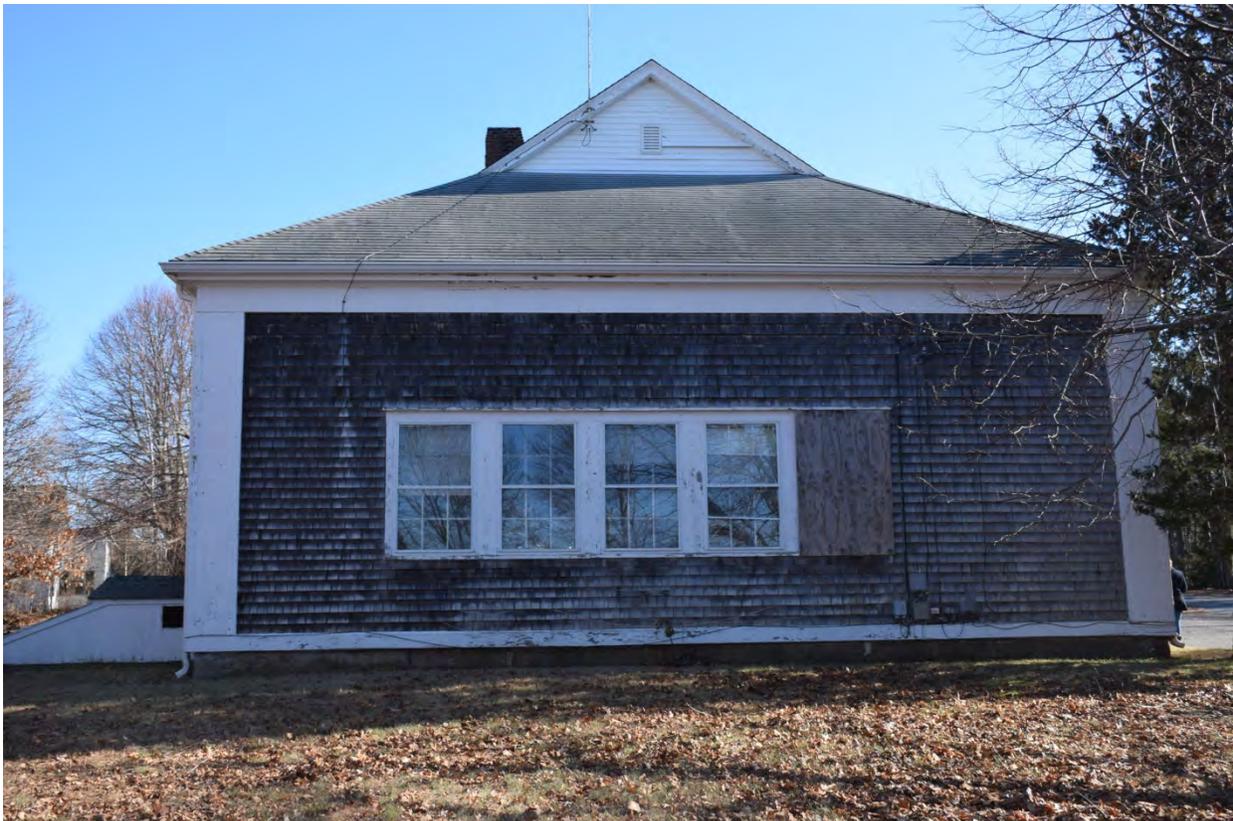
Photo 4: West Elevation

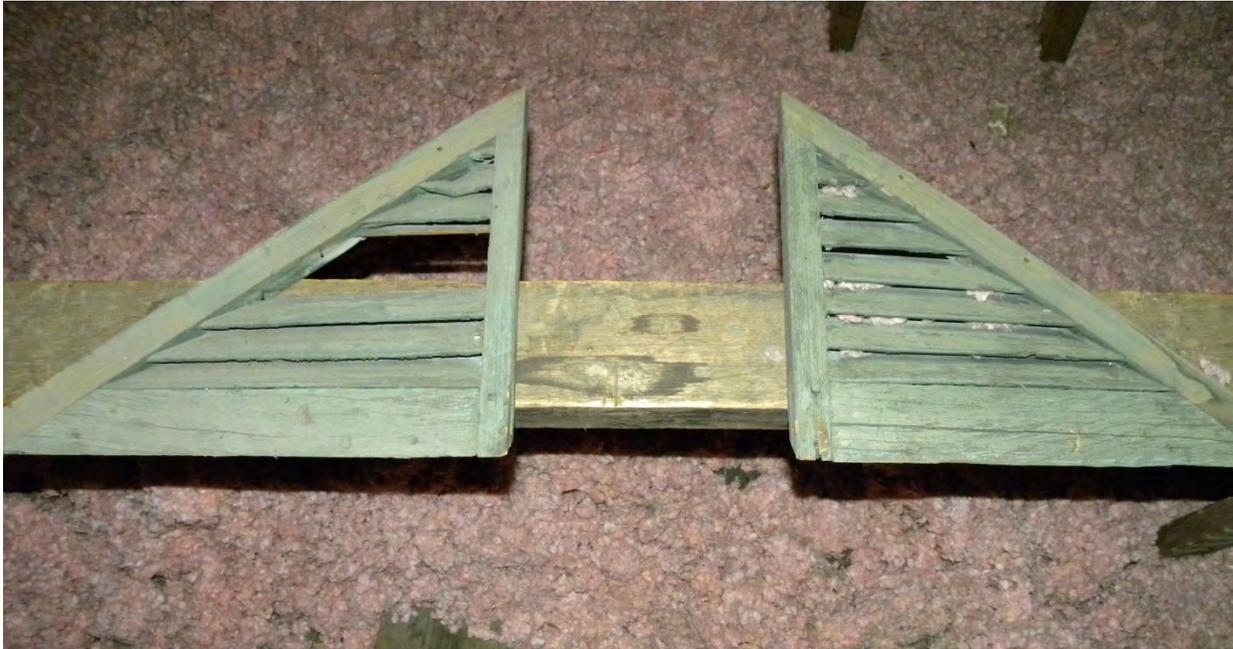
Photo 9: Original shutters from the front gable were found in the attic

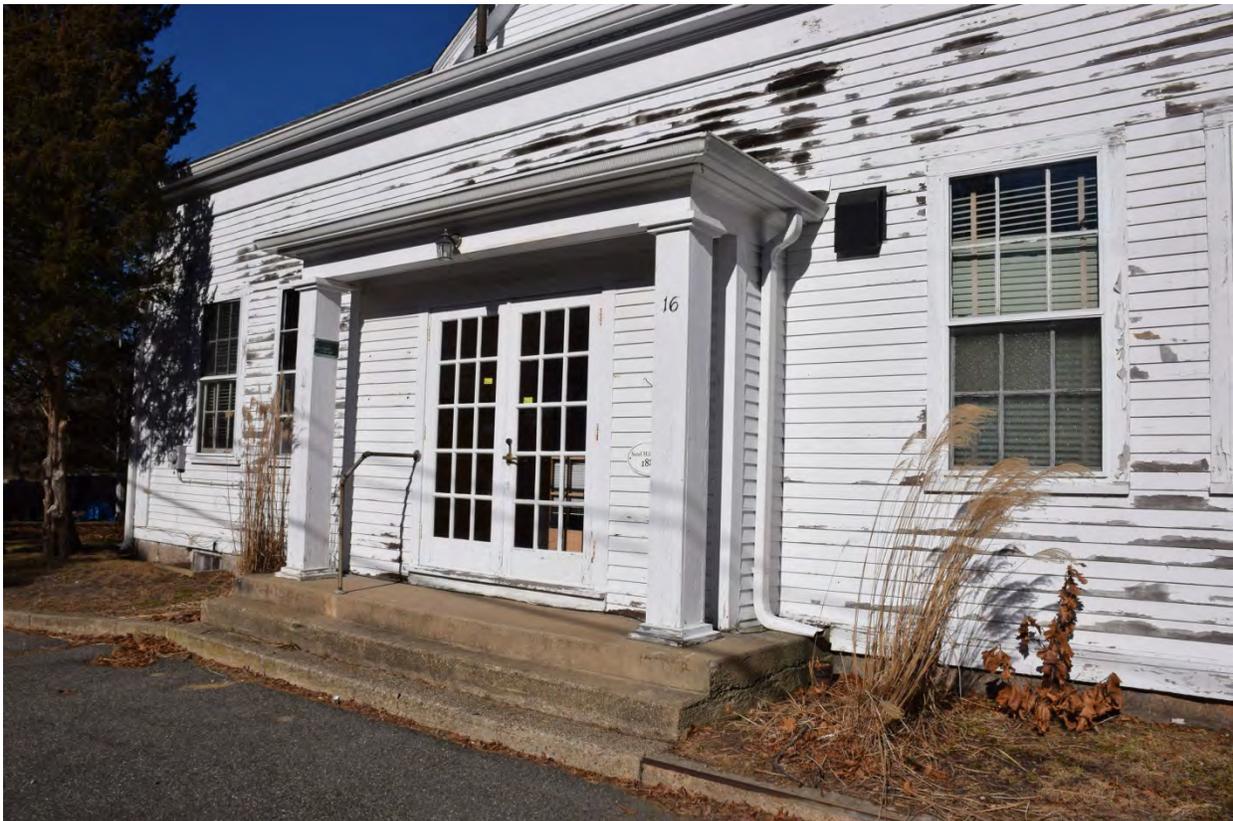
By comparing the historic photograph with the building today, there are a number of other obvious changes that have occurred at the building exterior over time. The black and white historic image shows that the clapboards and trim were of different shades; the trim boards being light colored or white, while the clapboards are a darker tone. Window placement, sizes, and details were different in the historical image. The front gable originally featured trim boards that panelized clapboards in a “stick style” treatment. The attic was vented by darker toned louvers. These louvers are stored in the building’s attic, and indicate that their original color was green (see photo 9) The original windows featured shutters, which were most likely painted the same green color. A hip-roofed entry canopy was supported by wood brackets, and overhung the recessed entry doors. These Victorian features with replaced with an entry porch that was built in a classical revival style as part of the 1935 Works Project Administration (WPA) renovations (see photos 10 and 11)

Photo 10: The 1935 WPA porch

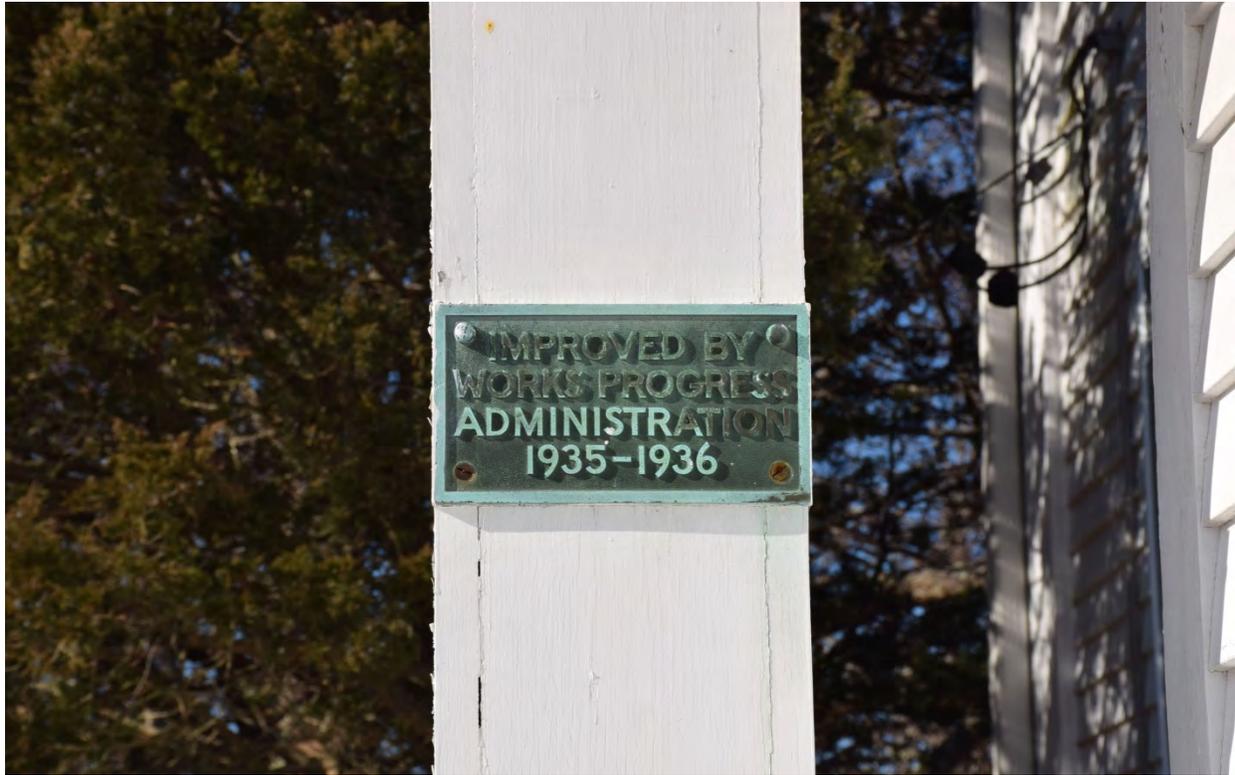
Photo 11: Bronze commemorative plaque from the 1935 renovation

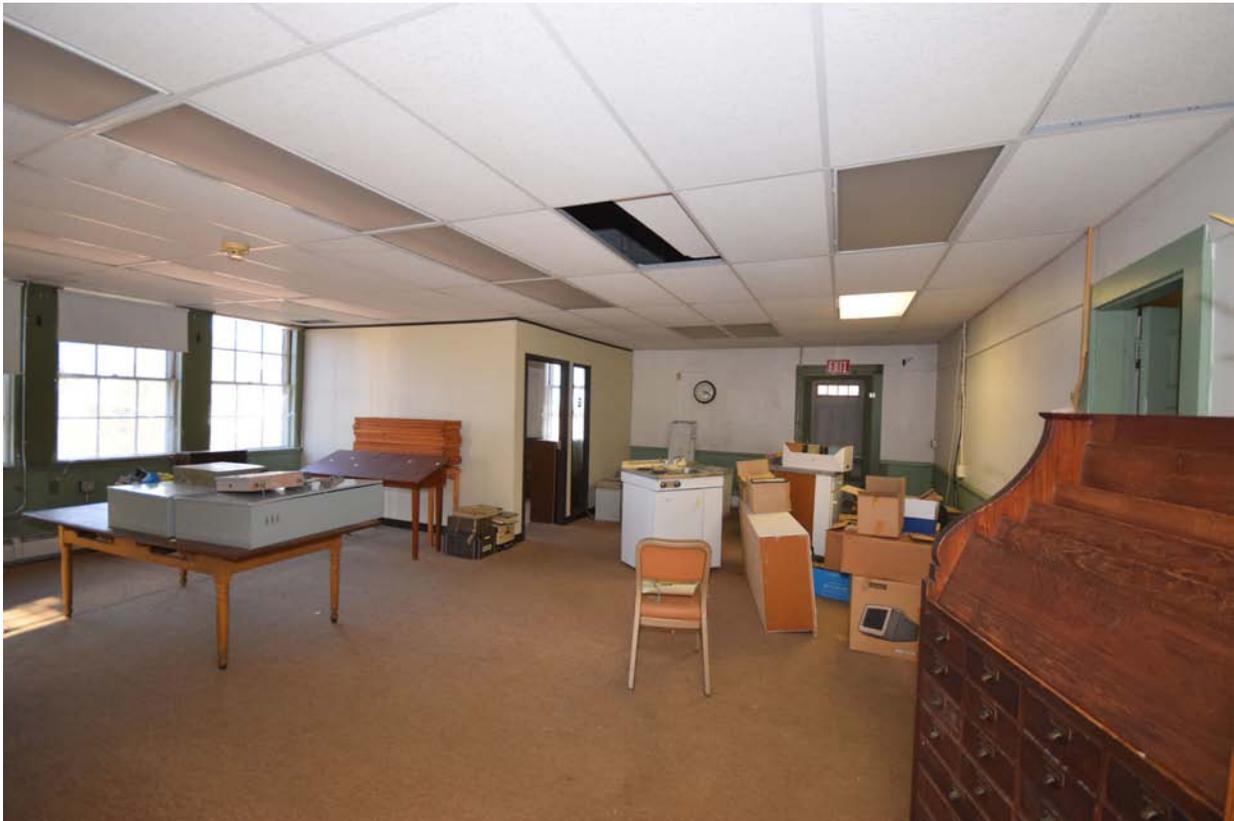
toilet rooms. Renovations for the school superintendent office use further subdivided the space, adding partitions to create smaller private offices (see photos 15 and 16).

Photo 15: Current interior view of northwest corner of the building

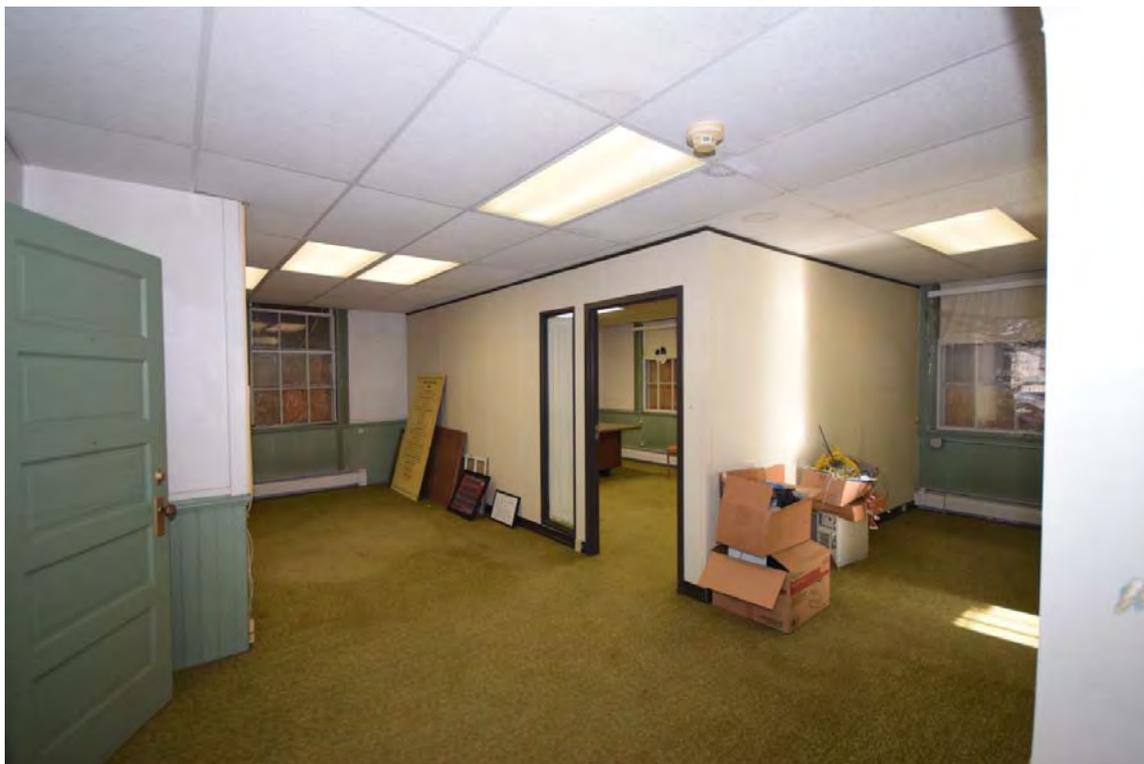
Photo 16: Current interior view northeast corner of the building

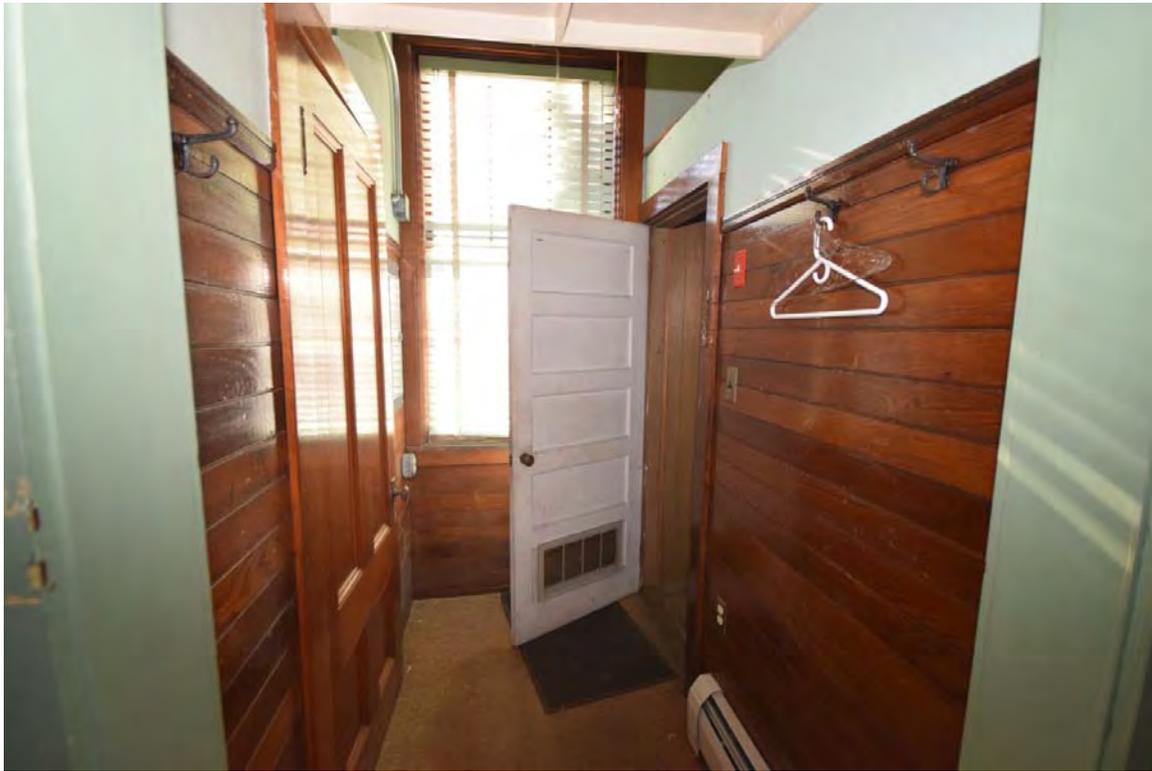
Photo 17: Current interior view south end of the building near men's toilet room and door to basement stair

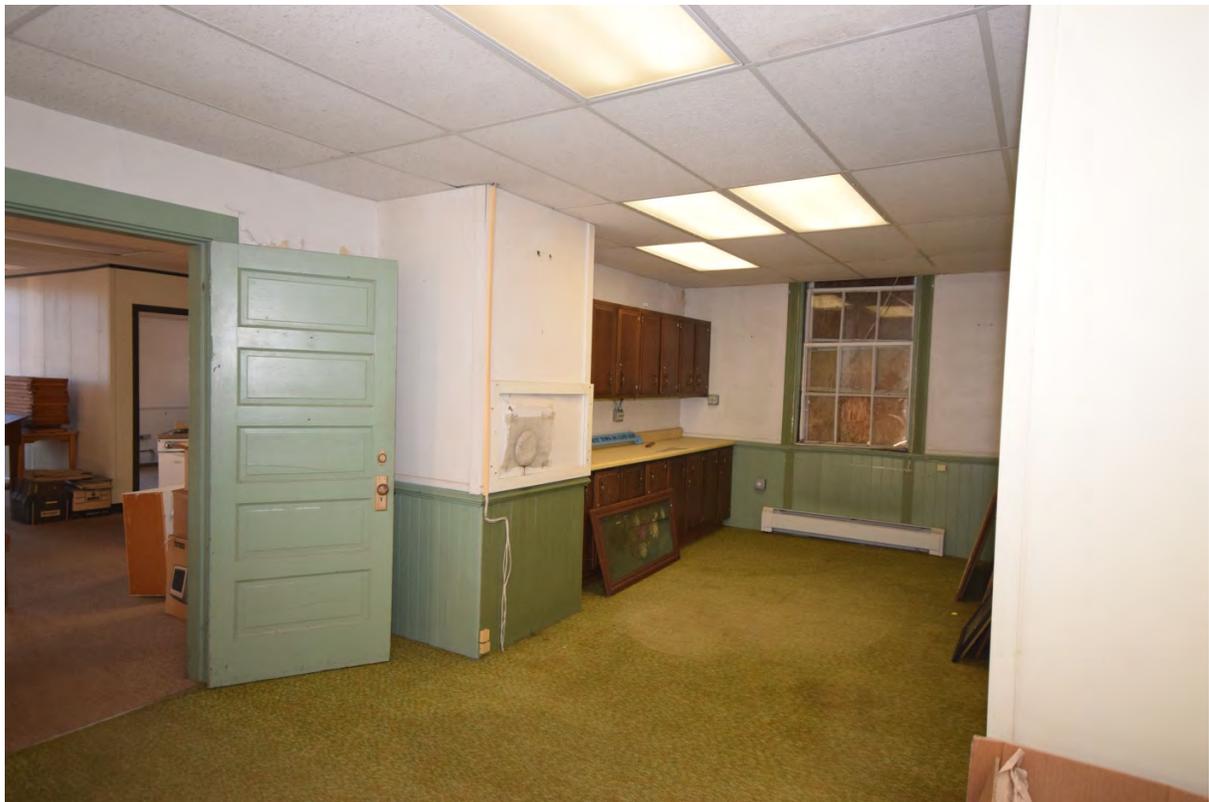
Interior walls feature a painted bead board wainscot with chair rail moulding. There are paneled doors, and kitchenette cabinetry from the 1935 renovation (see photo 19), as well as newer cabinetry from 1980's renovation (see photos 18 and 20).

Photo 18: Current interior view shows chimney and circa 1980 cabinetry

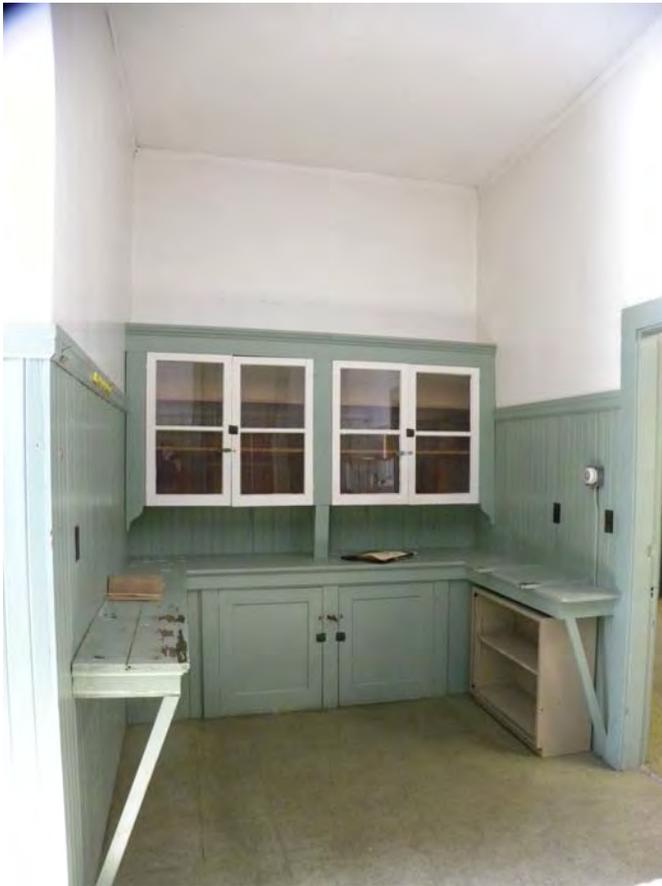
Photo 19: Detail of built-in cabinetry

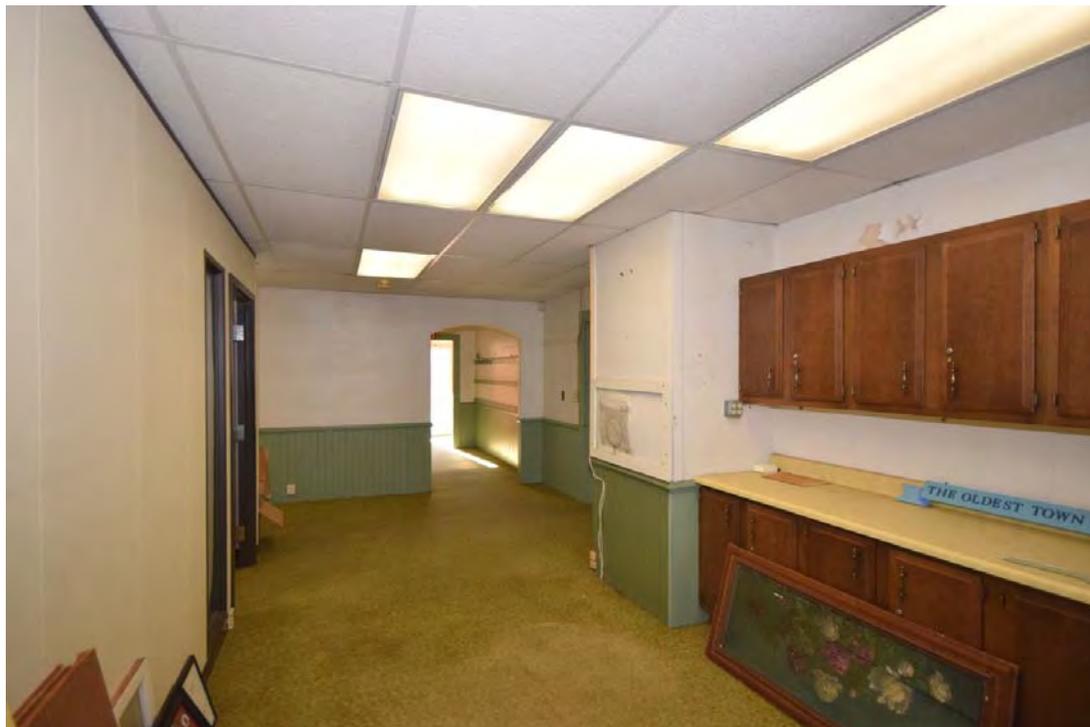
Photo 20: Current interior view

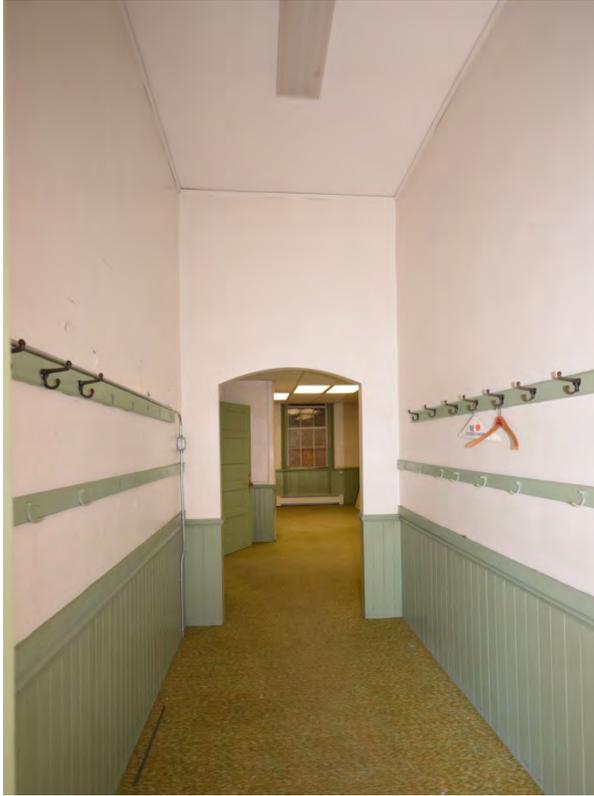
Photo 21: Entry corridor from 1935 renovation

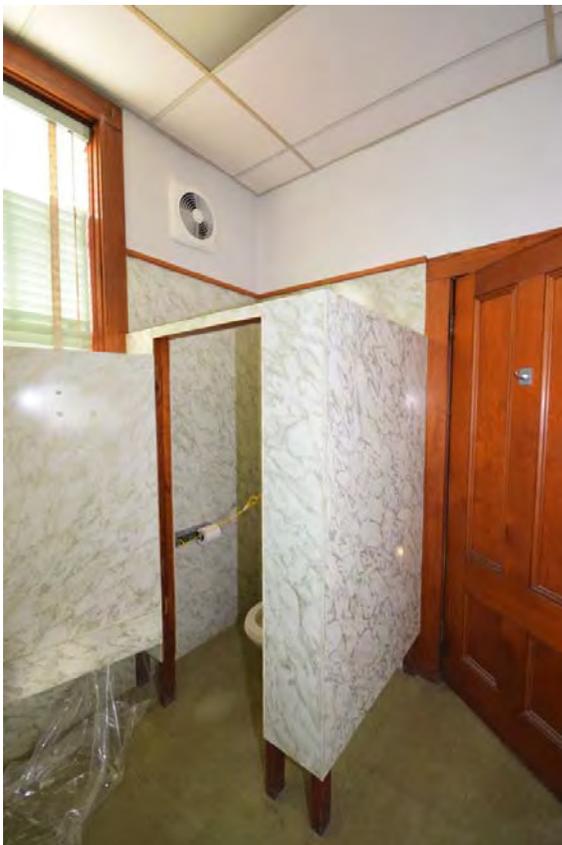
There is a currently a toilet room for each gender, and these also feature a layering of finishes. Presently walls and privacy partitions are faced with plastic laminate, most likely from the 1980's renovation. Floors are finished with vinyl tiles and linoleum, and the linoleum was identified as asbestos containing in the 2012 hazardous materials assessment. Ceilings are the same suspended acoustical ceiling tile system that is used in the former classrooms. The plumbing fixtures are old, but not of historic significance, and should be replaced when work is done on the building (see photos 22 and 23). As part of any renovation, these toilet rooms should be reconfigured to provide accessibility for all.

Photo 22: Detail at women's toilet room

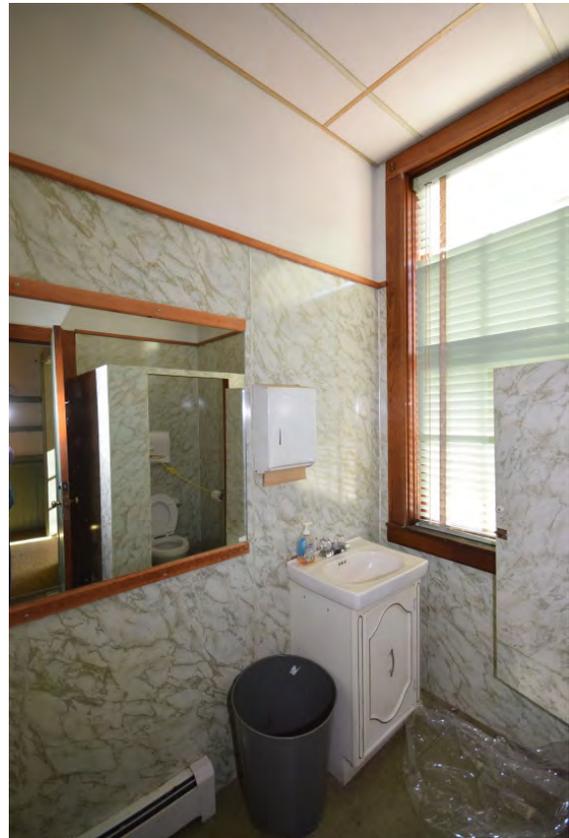
Photo 23: Detail at women's toilet room

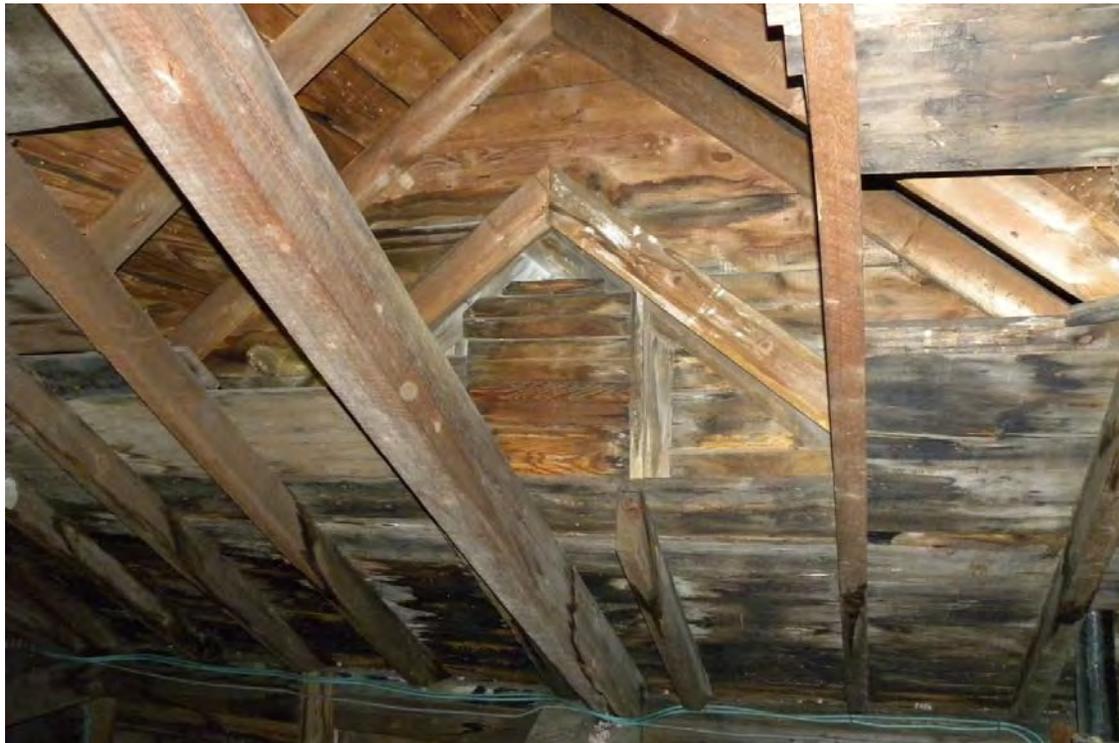
Photo 25: Detail view in attic shows the front gable with framed openings for louver

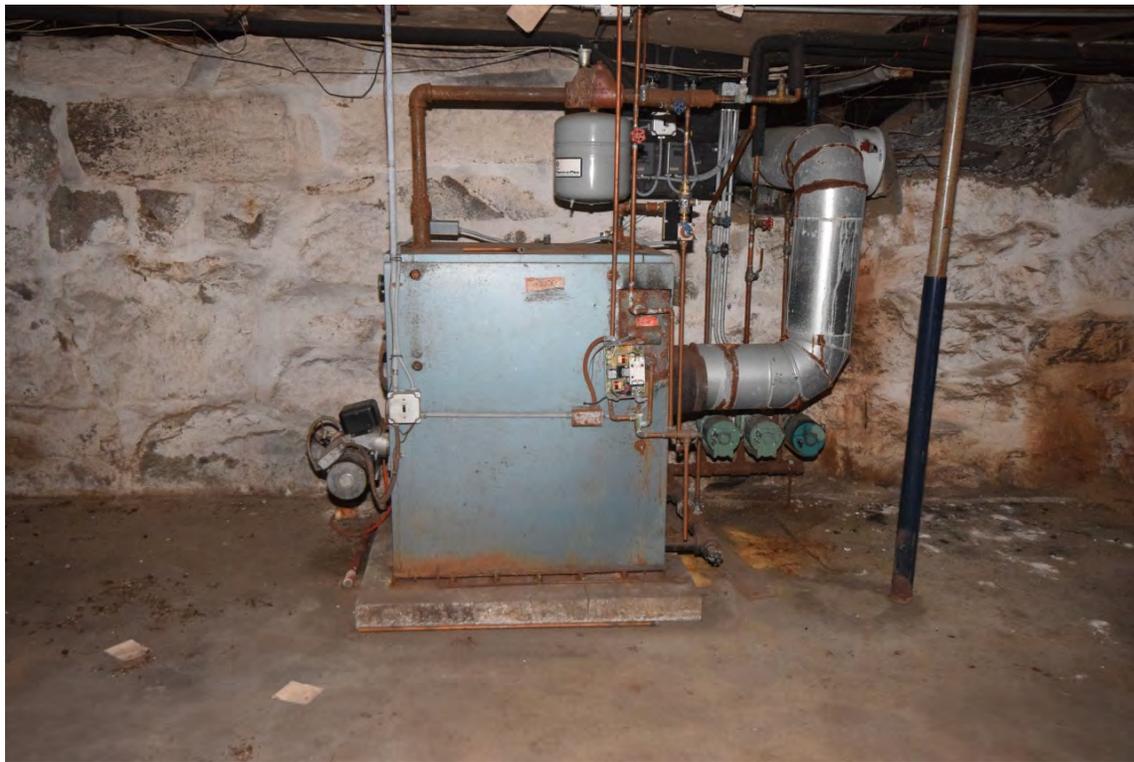
Photo 28: Boiler.

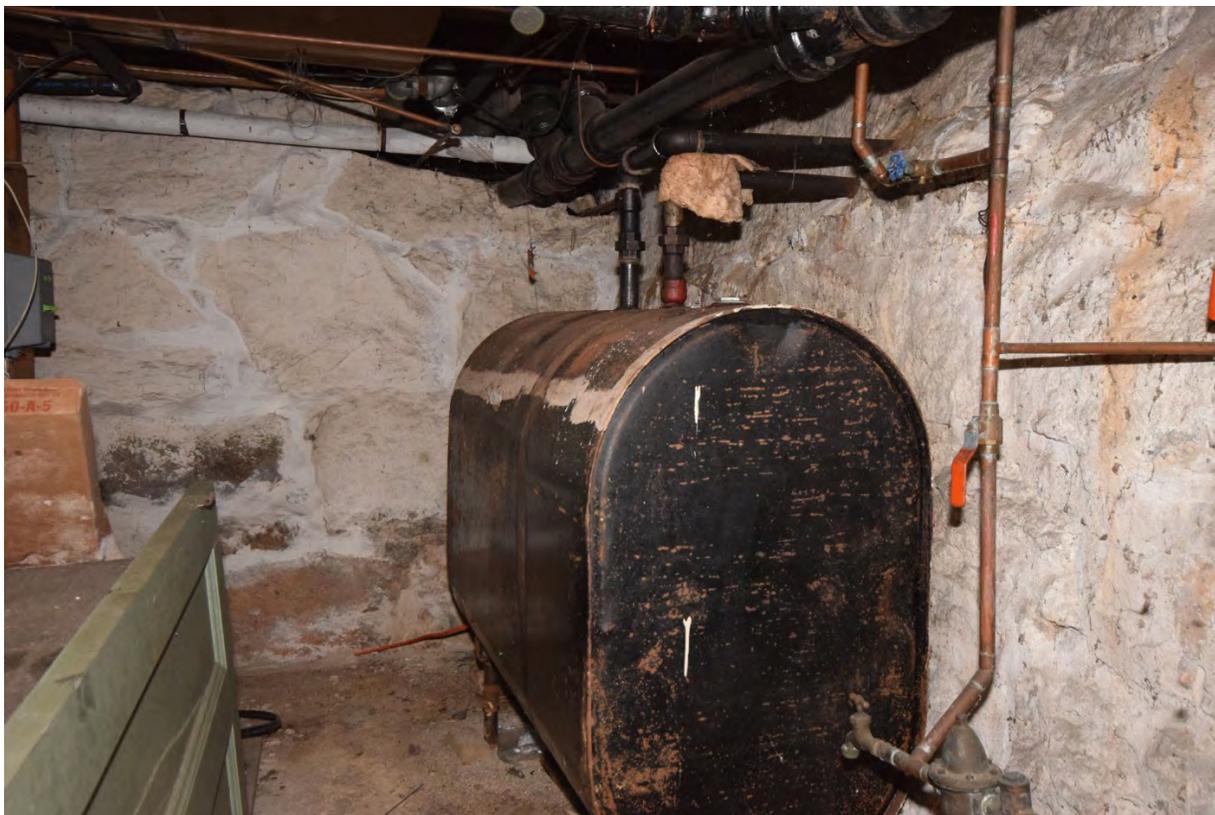
Photo 29: Fuel oil tank is located in a separate room in the southeast corner of the basement, along with telephone and data panels.

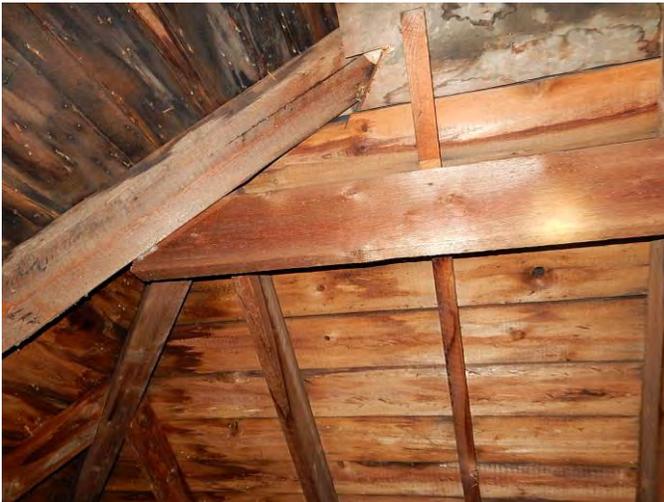
2. Framing at hips at ends of Dutch hip walls. A 4x7 rafter supports a 2x8 purlin.

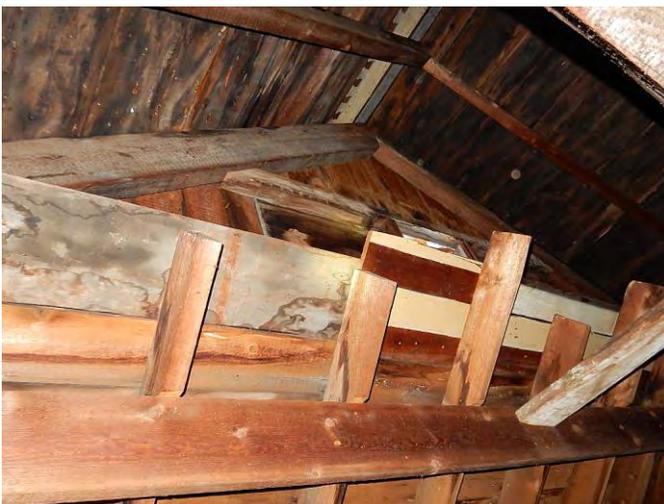
3. The Dutch hip wall is supported on a 2x8 purlin.

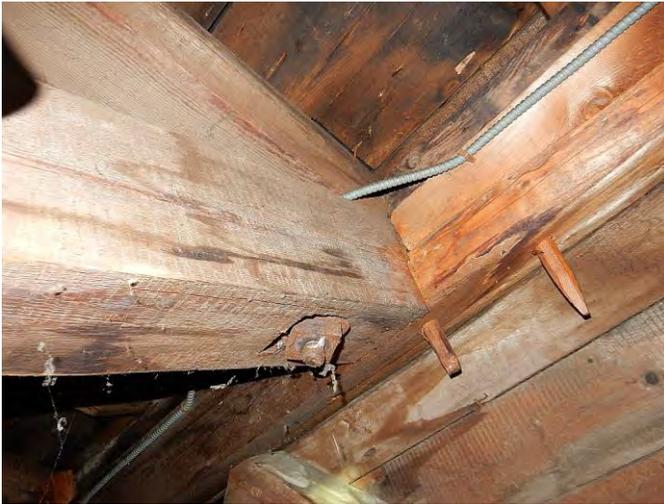
4. Roof truss heel bearing on wall plate. Wall plate is lap spliced and tied with two pegs.

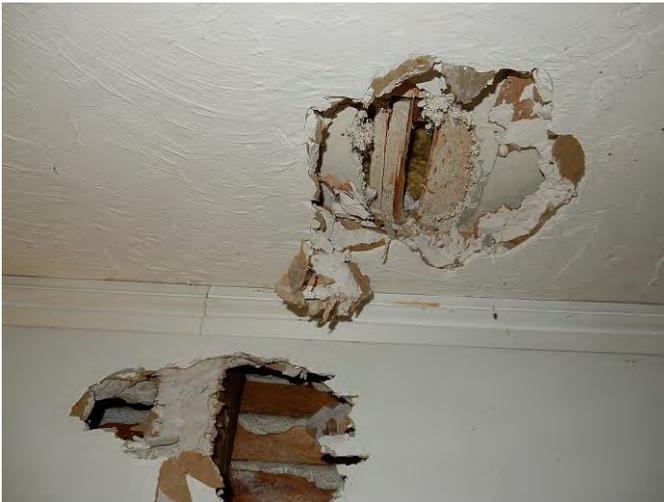
5. Openings to investigate the center wall running on a north south axis. There is no beam above the wall. This wall is supporting ceiling joists.

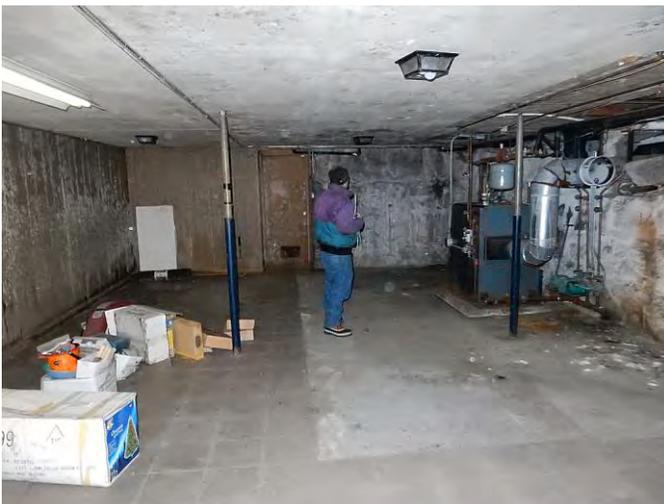
6. A basement at the west end of the building serves as a utility room.

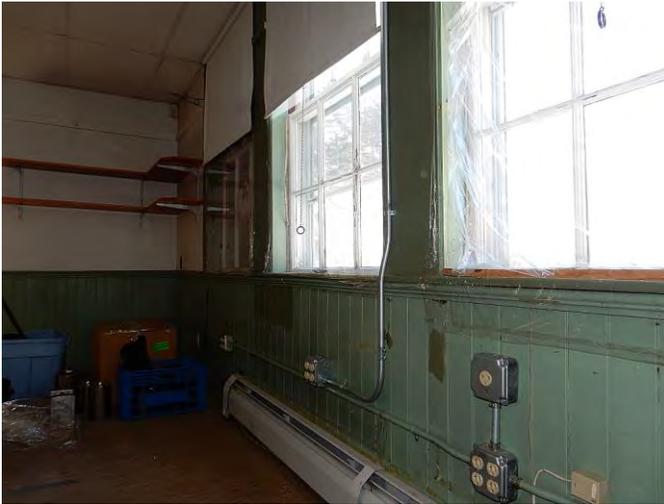
10. More windows with crowning in the window stools.

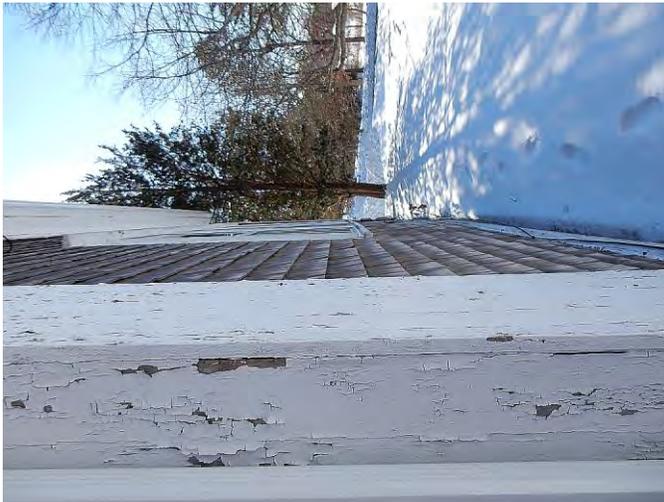
11. West wall looking south.
Picture is rotated on its side. The wall is bowed out at its base.
